**BMW 3: 1HEJ894**

**Limited Technical Inspection**

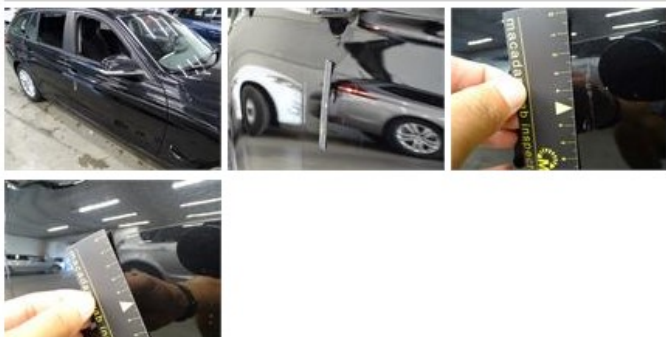
Door F R, Bump(s) and scratch(es), LI - Repair and paint (complete) 318,35
