SKODA Octavia: 1HAU117			
Vinnnumber:	<b>TMBJG7NE3E0229261</b>	Versionname:	<b>OCTAVIA COMBI Ambition 105PK</b>
First Registrationdate:	<b>5/06/2014</b>	Fiscalpower:	
Expertise Mileage:	<b>111373</b>	Power Kw:	<b>77</b>
Bodytype:	<b>Break</b>	Body color:	<b>Light Grey</b>
Gearbox:	<b>MAN 5 VIT</b>	Paint type:	<b>Metalic</b>
Transmission:		Rims summer:	<b>Steel</b>
Fueltype:	<b>Diesel</b>	Oil level:	<b>OK</b>
Battery functioning:	<b>Yes</b>	Parking lot:	<b>4105</b>
Number of doors:	<b>5</b>		
Number of seats:	<b>5</b>		
Number head rests:	<b>5</b>		
Rims summer:	<b>Steel</b>		
Category:	<b>Passenger Car</b>		
Oil level:	<b>OK</b>		
Registration Certificate Car (BE):	<b>Yes</b>

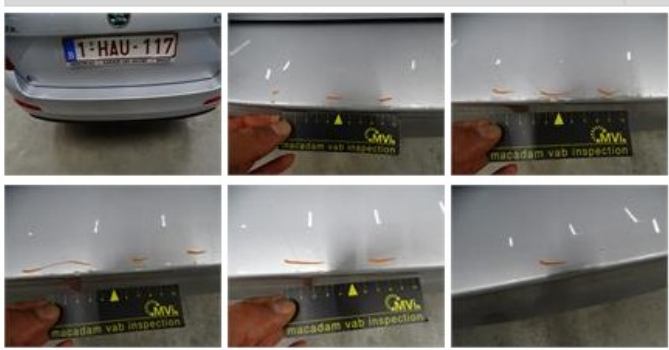
Assistance equipment			
Spare wheel	<b>Yes</b>	Jack	<b>Yes</b>
Total cost ex VAT			904,74
Bumper R, Scratch(es), LI - Repair and paint (complete)			211,80

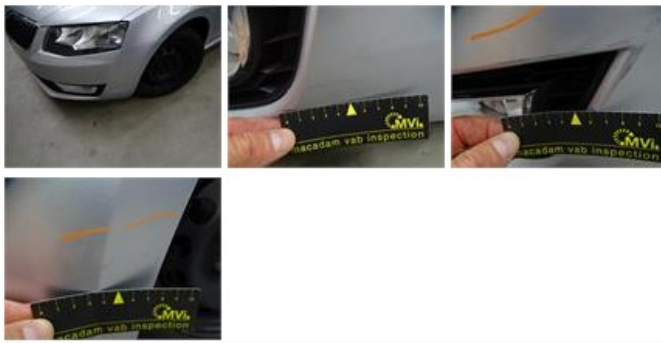
Front bumper, Scratch(es), LI - Repair and paint (complete)	211,80
---	--------
