BMW 3 BERLINE: 1LJU800

Limited Technical Inspection

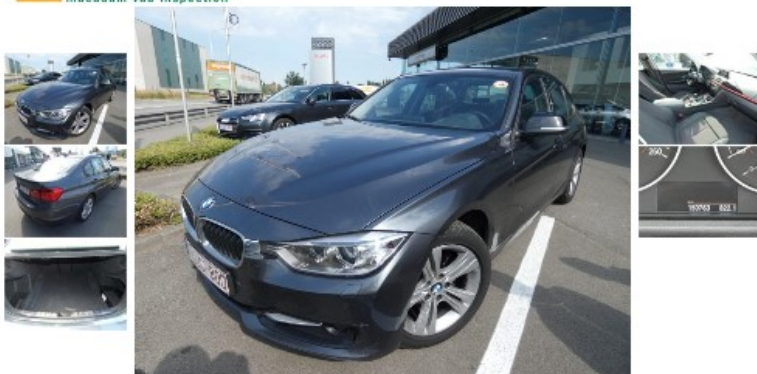
Vinnumber:	WBA3D11070P701628	Versionname:	2.0 318D (100KW) BERLINE
First Registrationdate:	7/10/2015	Fiscalpower:	
Expertise Mileage:	150763	Power Kw:	100
Bodytype:	Berline	Body color:	Grey
Gearbox:	MAN 6 VIT	Paint type:	Metalic
Transmission:	Back	Rims summer:	Aluminium
Fueltype:	Diesel	Oil level:	OK
Maintenance:	OK	Parking lot:	1113
Battery functioning:	Yes		
Number of doors:	4		
Number of seats:	5		
Number head rests:	5		
Rims summer:	Aluminium		
Category:	Passenger Car		
Oil level:	OK		
Registration Certificate Car (BE):	Yes
