**FORD Fiesta: 1GWD722**

**Limited Technical Inspection**

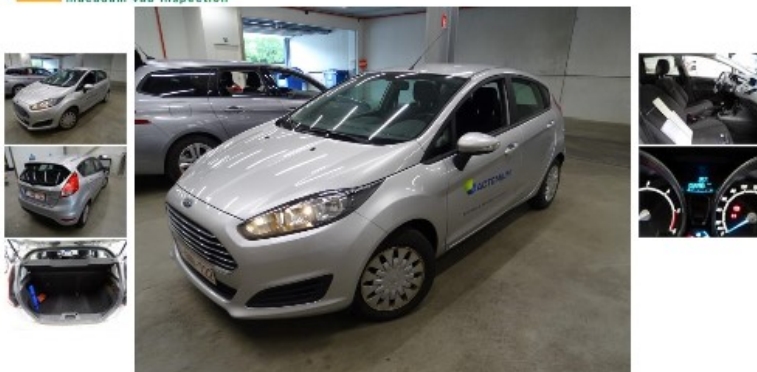
Vinnumber:	<b>WF0DXXGAKDEJ43004</b>	Versionname:	<b>FIESTA BER Trend ECONetic S/S 95PK</b>
First Registrationdate:	<b>16/05/2014</b>	Fiscalpower:	
Expertise Mileage:	<b>102298</b>	Power Kw:	<b>70</b>
Bodytype:		Body color	<b>Grey</b>
Gearbox:	<b>MAN 5 VIT</b>	Paint type	<b>Metalic</b>
Transmission:	<b>Front</b>	Rims summer	<b>Steel</b>
Fueltype:	<b>Diesel</b>	Oil level	<b>OK</b>
Maintenance	<b>OK</b>	Parking lot	<b>3432</b>
Battery functioning	<b>Yes</b>		
Number of doors	<b>5</b>		
Number of seats	<b>5</b>		
Number head rests	<b>4</b>		
Rims summer	<b>Steel</b>		
Category	<b>Passenger Car</b>		
Oil level	<b>OK</b>		
Registration Certificate Car (BE)	<b>Yes</b>
