**RENAULT Megane: 1FMY112**

**Limited Technical Inspection**

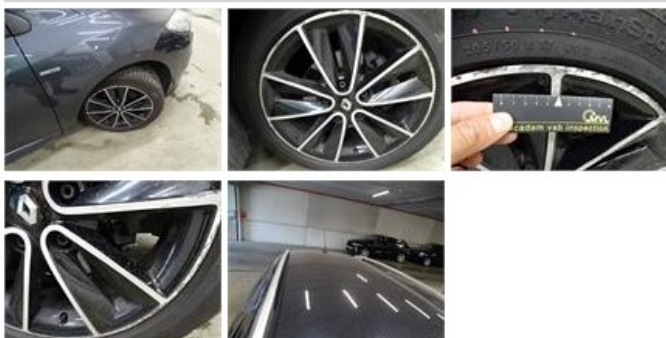
Alloy rim F R polished, Scratch(es), LI - Repair and paint (complete)	<b>95,00</b>
-----------------------------------------------------------------------	--------------

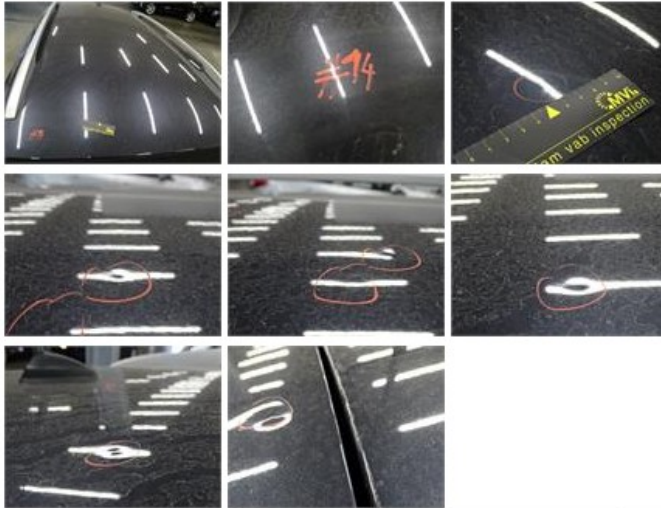
Roof, Hail damage, PDR - Hail 350,00
