VOLVO V40: 1GUR665			
Vinnnumber:	YV1MV8481E2153516	Versionname:	V40 D2 Base 115PK
First Registrationdate:	6/05/2014	Fiscalpower:	
Expertise Mileage:	136422	Power Kw:	84
Bodytype:		Body color:	Blue
Gearbox:	MAN 6 VIT	Paint type:	Metalic
Transmission:		Rims summer:	Aluminium
Fueltype:	Diesel	Oil level:	OK
Battery functioning:	Yes	Parking lot:	1114
Number of doors:	5		
Number of seats:	5		
Number head rests:	5		
Rims summer:	Aluminium		
Category:	Passenger Car		
Oil level:	OK		
Registration Certificate Car (BE):	Yes

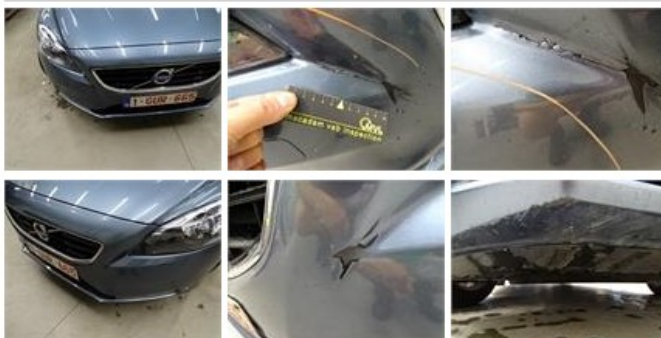
Assistance equipment			
Repair kit	Yes	Compressor	Yes
Total cost ex VAT			905,08
Front bumper, Dent(s) and scratch(es), LI - Repair and paint (complete)			211,80
