PEUGEOT 308: 1FIY042

Limited Technical Inspection

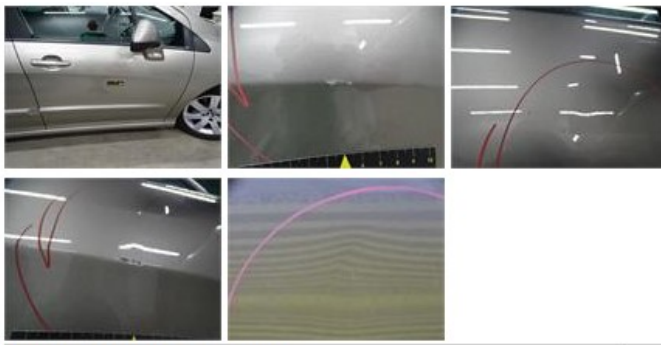
Door F R, Dent(s) and scratch(es), LI - Repair and paint (complete)

318,35

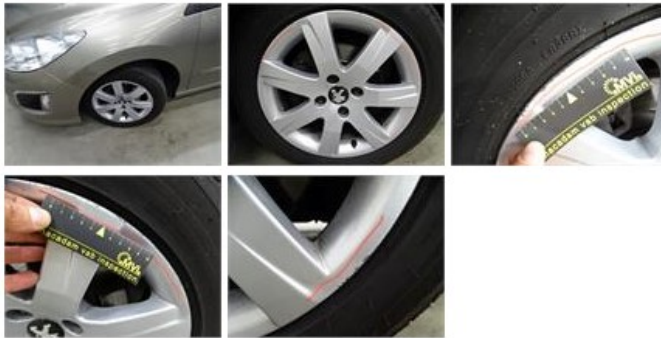
Bumper R, Scratch(es), Acceptable	0,00
<i>No pictures to display</i>	
Alloy rim R L, Scratch(es), Acceptable	0,00
<i>No pictures to display</i>	
Alloy rim F L, Scratch(es), LI - Repair and paint (complete)	95,00
