BMW X5: 1PHT657			
Vinnnumber:	WBALS010400T84691	Versionname:	2.0 XDRIVE25D (155KW)
First Registrationdate:	8/07/2016	Fiscalpower:	4WD AUTO
Expertise Mileage:	75039	Power Kw:	155
Bodytype:	SUV	Body color:	Black
Gearbox:	Automatic	Paint type:	Metalic
Transmission:	4 Weel	Rims summer:	Aluminium
Fueltype:	Diesel	Oil level:	OK
Battery functioning:	Yes	Parking lot:	4119
Number of doors:	5		
Number of seats:	7		
Number head rests:	7		
Rims summer:	Aluminium		
Category:	Passenger Car		
Oil level:	OK		
Registration Certificate Car (BE):	Yes

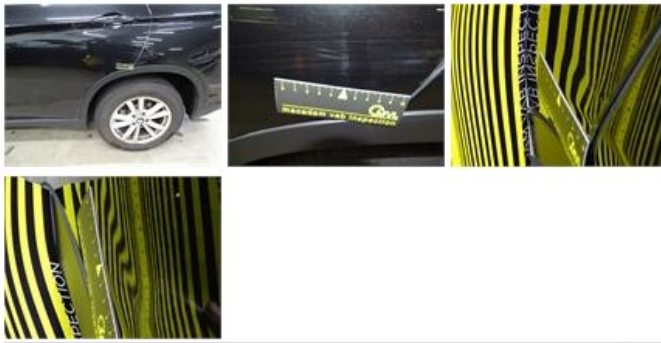
Door R R, Scratch(es), Acceptable	0,00
<i>No pictures to display</i>	
Wing R R, Scratch(es), Acceptable	0,00
<i>No pictures to display</i>	
Door R L, Dent(s) and scratch(es), LI - Repair and paint (complete)	382,02
