BMW 1 HATCH: 1LDH641			
Vinnnumber:	WBA1V910605B19103	Versionname:	1.5 116D EFFICIENTDYNAMICS EDIT. (85KW)
First Registrationdate:	27/08/2015	Expertise Mileage:	48090
Bodytype:	Hatchback	Fiscalpower:	85
Gearbox:	MAN 6 VIT	Power Kw:	85
Transmission:		Body color:	Dark Blue
Fueltype:	Diesel	Paint type:	Metalic
Battery functioning:	Yes	Rims summer:	Aluminium
Number of doors:	5	Oil level:	OK
Number of seats:	5	Parking lot:	1105
Number head rests:	5		
Rims summer:	Aluminium		
Category:	Passenger Car		
Oil level:	OK		
Registration Certificate Car (BE):	Yes

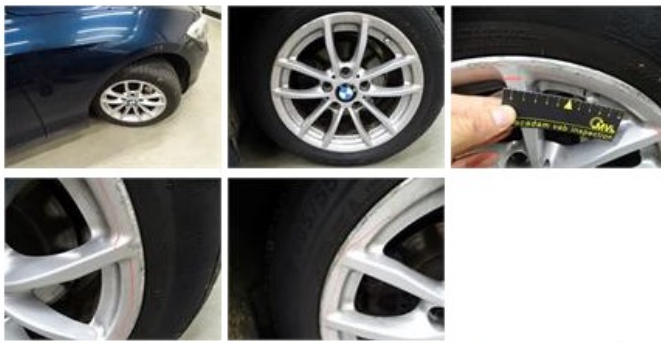
Door F L, Scratch(es), Acceptable	0,00
<i>No pictures to display</i>	
Alloy rim F R, Scratch(es), LI - Repair and paint (complete)	95,00

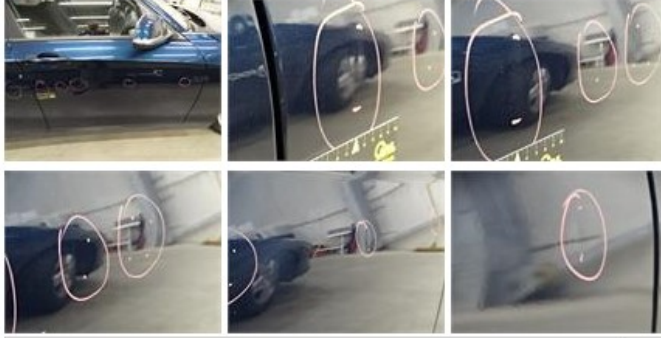
Door F R, Dent(s), LI - Repair and paint (complete) 318,35
