BMW 5: 1FNY719

Limited Technical Inspection

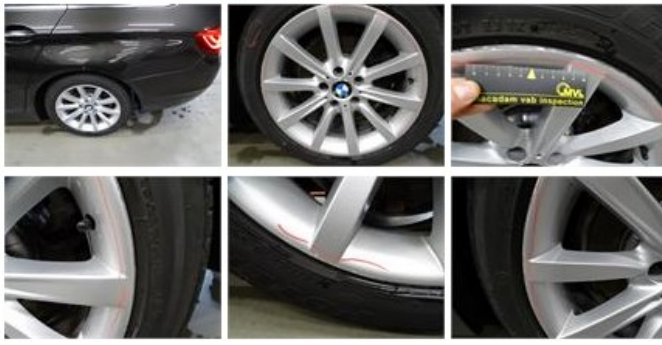
Runflat	Yes
Total cost ex VAT		95,00
Door R L, Scratch(es), Acceptable		0,00
<i>No pictures to display</i>		
Alloy rim F R, Scratch(es), Acceptable		0,00
<i>No pictures to display</i>		
Wing R R, Dent(s), Acceptable		0,00
<i>No pictures to display</i>		
Alloy rim R R, Scratch(es), Acceptable		0,00
<i>No pictures to display</i>		
Alloy rim R L, Scratch(es), LI - Repair and paint (complete)		95,00
