**RENAULT Grand Scenic: 1HFB602**

**Limited Technical Inspection**

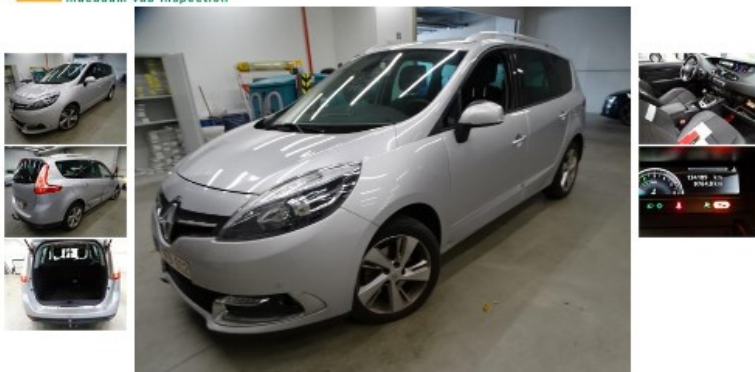
Vinnnumber:	<b>VF1JZ14M650054061</b>	Versionname:	<b>GRAND SCENIC Energy R-Movie 5pl.110PK</b>
First Registrationdate:	<b>4/07/2014</b>	Fiscalpower:	
Expertise Mileage:	<b>134189</b>	Power Kw:	<b>81</b>
Bodytype:		Body color:	<b>Silver</b>
Gearbox:	<b>MAN 6 VIT</b>	Paint type:	<b>Metalic</b>
Transmission:		Rims summer:	<b>Aluminium</b>
Fueltype:	<b>Diesel</b>	Oil level:	<b>OK</b>
Battery functioning:	<b>Yes</b>	Parking lot:	<b>1123</b>
Number of doors:	<b>5</b>		
Number of seats:	<b>5</b>		
Number head rests:	<b>5</b>		
Rims summer:	<b>Aluminium</b>		
Category:	<b>Passenger Car</b>		
Oil level:	<b>OK</b>		
Registration Certificate Car (BE):	<b>Yes</b>
