VOLVO V60: 1HCA846

Limited Technical Inspection

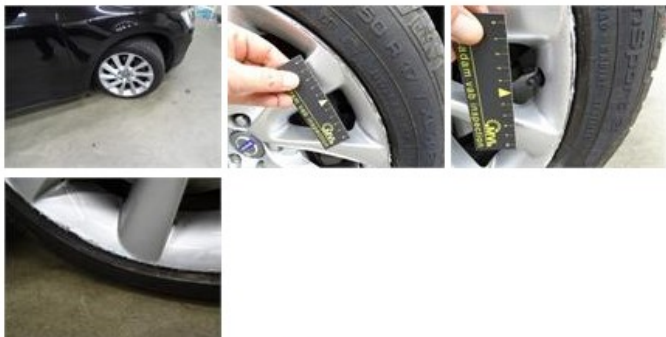
Repair kit	Yes	Compressor	Yes
Total cost ex VAT			95,00
Alloy rim F R, Scratch(es), LI - Repair and paint (complete)			95,00
