BMW 3: QF8785			
Vinnumber:	WBA3J31050F813581	Versionname:	3 BER 318dX 143PK
First Registrationdate:	1/01/2020	Fiscalpower:	
Expertise Mileage:	118972	Power Kw:	105
Bodytype:		Body color	Black
Gearbox:	MAN 6 VIT	Paint type	Metalic
Transmission:		Rims summer	Aluminium
Fueltype:	Diesel	Oil level	OK
Battery functioning	Yes	Parking lot	4301
Number of doors	4		
Number of seats	5		
Number head rests	5		
Rims summer	Aluminium		
Category	Passenger Car		
Oil level	OK

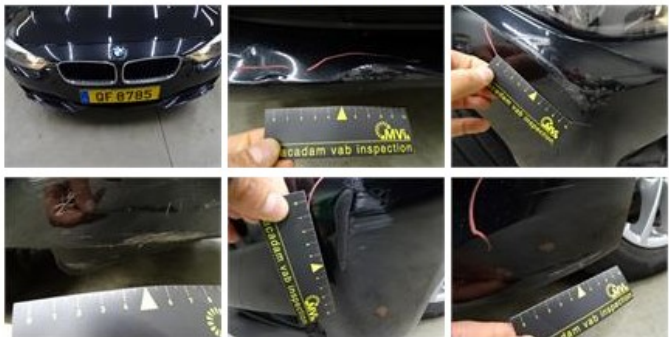
Assistance equipment			
Repair kit	Yes	Compressor	Yes
Total cost ex VAT			929,95
Wing R R, Scratch(es), Acceptable			0,00
<i>No pictures to display</i>			
Front bumper, Dent(s) and scratch(es), LI - Repair and paint (complete)			211,80
