BMW 3 TOURING: 1 SRV162

Limited Technical Inspection

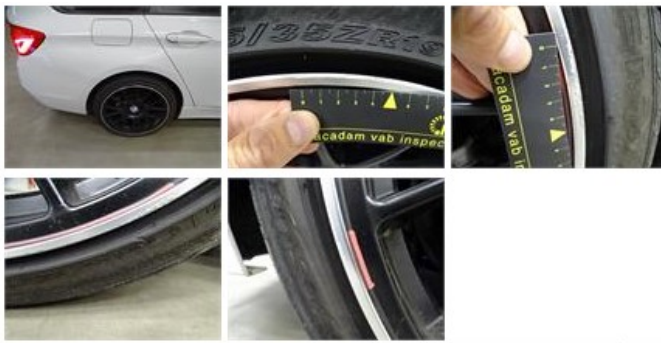
Total cost ex VAT	340,00
Alloy rim F L polished, Scratch(es), Acceptable	0,00
<i>No pictures to display</i>	
Alloy rim F R, Scratch(es), Acceptable	0,00
<i>No pictures to display</i>	
Ignition key, Missing, E - Replace	150,00
<i>No pictures to display</i>	
Alloy rim R R polished, Scratch(es), LI - Repair and paint (complete)	95,00

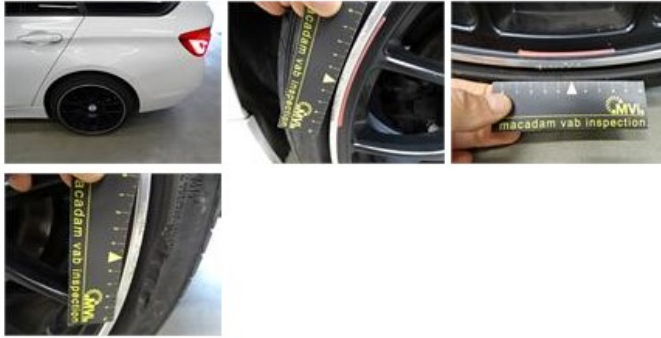
Alloy rim R L polished, Scratch(es), LI - Repair and paint (complete) 95,00
