BMW 5 GT: 1FHT630

Limited Technical Inspection

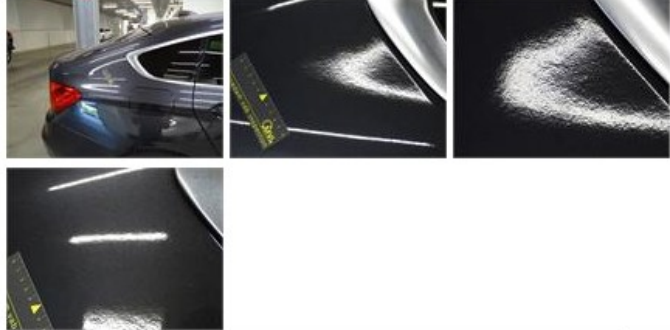
Front bumper, Scratch(es), Acceptable	0,00
No pictures to display	
Bumper R, Scratch(es), Acceptable	0,00
No pictures to display	
Wing R R, Bad repair, Paint	0,00
