RENAULT Scenic: 1EZL395			
Vinnnumber:	VF1JZ14K649041583	Versionname:	SCENIC PriviEge 110PK
First Registrationdate:	29/04/2013	Fiscalpower:	
Expertise Mileage:	78291	Power Kw:	81
Bodytype:	Hatchback	Body color:	Brown
Gearbox:	MAN 6 VIT	Paint type:	Metalic
Transmission:	Front	Rims summer:	Aluminium
Fueltype:	Diesel	Oil level:	OK
Battery functioning:	Yes	Parking lot:	3206
Number of doors:	5		
Number of seats:	5		
Number head rests:	5		
Rims summer:	Aluminium		
Category:	Passenger Car		
Oil level:	OK

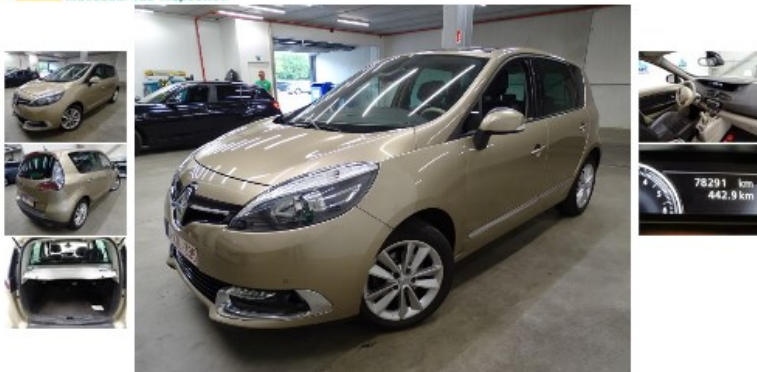
Limited Technical Inspection			
Airco functioning	OK	Battery functioning	Yes
Tires wear profile	OK	Power steering	Yes
Idle position	OK	Sound engine	OK
Engine startingtime	OK	Clutch test	OK
Exhaust gass	OK	Wiper fluid level	OK
Handbrake	OK	Transmission	OK
		Lighting	OK
		Wiperblades	OK

Degree of wear				
	205/55/16/95 V LightMetal			
Summer tyres:	Fr.L.	Continental: 5 mm	Fr.R.	Continental: 5 mm
	Re.L.	Continental: 6 mm	Re.R.	Continental: 6 mm
