VOLKSWAGEN GOLF VARIANT: 1LDA049

Limited Technical Inspection

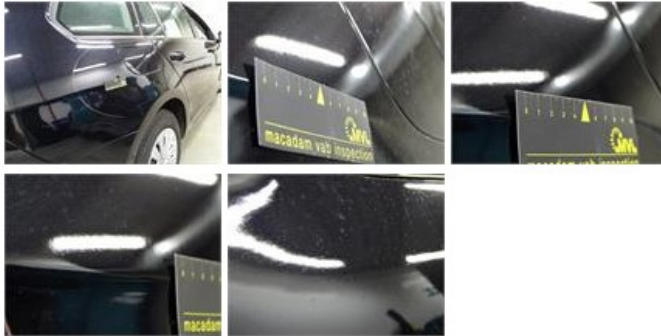
Door R L, Scratch(es), Acceptable	0,00
<i>No pictures to display</i>	
Bumper R, Scratch(es), Acceptable	0,00
<i>No pictures to display</i>	
Wing R L, Dent(s) and scratch(es), Acceptable	0,00
<i>No pictures to display</i>	
Door F R, Scratch(es), Acceptable	0,00
<i>No pictures to display</i>	
Interior, Dirty, Acceptable	0,00
<i>No pictures to display</i>	
Wing R R, Bad repair, LI - Repair and paint (partial)	0,00
