AUDI A3: 1GHZ846

Limited Technical Inspection

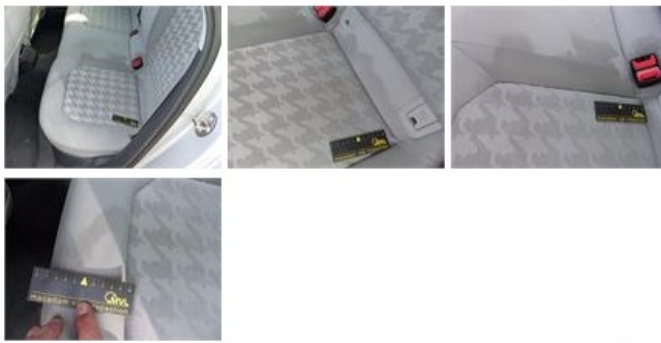
Repair kit	Yes	Compressor	Yes
Total cost ex VAT			386,80
Wing F R, Scratch(es), Acceptable			0,00
<i>No pictures to display</i>			
Door R L, Dent(s), Acceptable			0,00
<i>No pictures to display</i>			
Roof, Dent(s), Acceptable			0,00
<i>No pictures to display</i>			
Seat cover R L, Stain, Cleaning			25,00

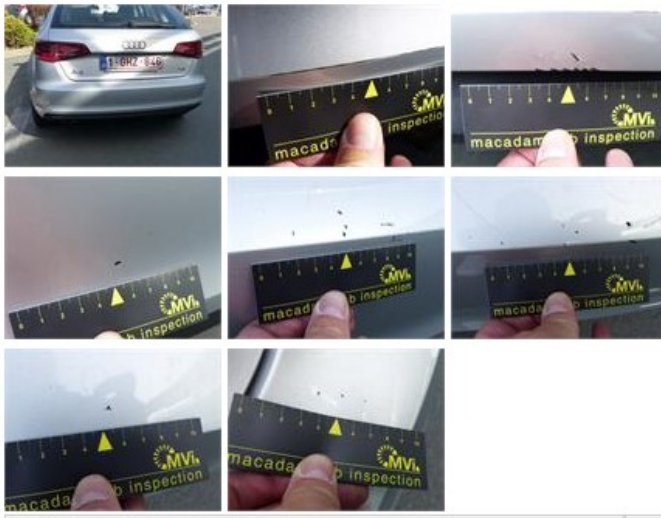
Bumper trim R, Scratch(es), Acceptable 0,00
