**BMW 4 GRAN COUPE: KY1976**

**Limited Technical Inspection**

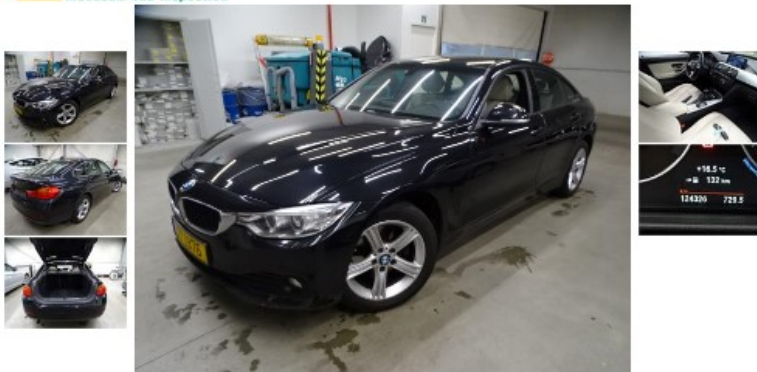
Vinnumber:	<b>WBA4B71050D422208</b>	Versionname:	<b>2.0 420D XDRIVE (135KW) 4WD GRAN COUPE</b>
First Registrationdate:	<b>1/01/2020</b>	Fiscalpower:	
Expertise Mileage:	<b>124326</b>	Power Kw:	<b>135</b>
Bodytype:		Body color	<b>Black</b>
Gearbox:	<b>MAN 6 VIT</b>	Paint type	<b>Metalic</b>
Transmission:		Rims summer	<b>Aluminium</b>
Fueltype:	<b>Diesel</b>	Oil level	<b>OK</b>
Battery functioning	<b>Yes</b>	Parking lot	<b>1211</b>
Number of doors	<b>5</b>		
Number of seats	<b>5</b>		
Number head rests	<b>5</b>		
Rims summer	<b>Aluminium</b>		
Category	<b>Passenger Car</b>		
Oil level	<b>OK</b>
