MERCEDÉS A: 1HFL542			
Vinnumber:	WDD1760121V022492	Versionname:	A 180CDI BE Edition 109PK
First Registrationdate:	8/07/2014	Fiscalpower:	
Expertise Mileage:	26180	Power Kw:	80
Bodytype:		Body color	Grey
Gearbox:	MAN 6 VIT	Paint type	Metalic
Transmission:		Rims summer	Steel
Fueltype:	Diesel	Oil level	OK
Maintenance	NOT OK	Parking lot	2524
Battery functioning	Yes		
Number of doors	5		
Number of seats	5		
Number head rests	5		
Rims summer	Steel		
Category	Passenger Car		
Oil level	OK		
Registration Certificate Car (BE)	Yes

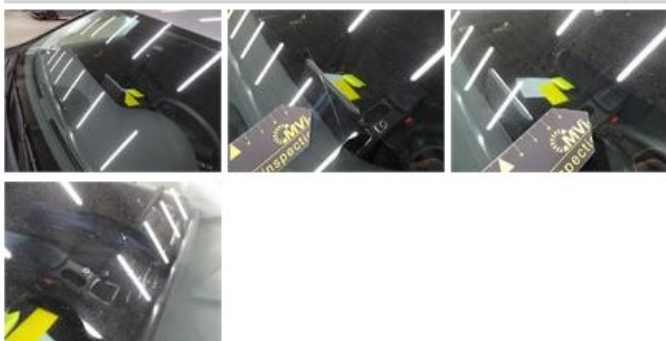
Assistance equipment			
Repair kit	Yes	Compressor	Yes
Total cost ex VAT			1222,20
Windscreen, Scratch(es), E - Replace			487,20
