**BMW 3: 1FMM712**

**Limited Technical Inspection**

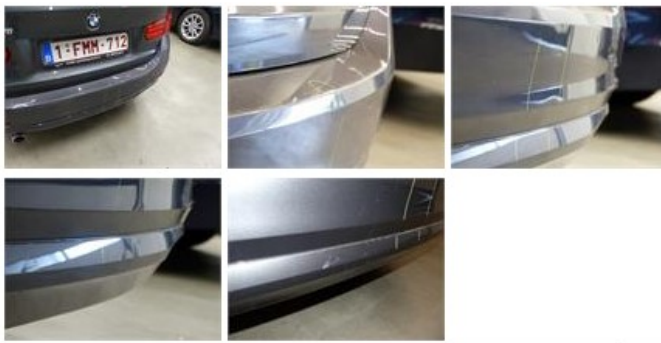
Total cost ex VAT	<b>1158,10</b>
Door R L, Scratch(es), Acceptable	<b>0,00</b>
<i>No pictures to display</i>	
Wing R L, Dent(s), Acceptable	<b>0,00</b>
<i>No pictures to display</i>	
Backrest cover F R, Scratch(es), Acceptable	<b>0,00</b>
<i>No pictures to display</i>	
Door R R, Scratch(es), Acceptable	<b>0,00</b>
<i>No pictures to display</i>	
Bumper R, Dent(s) and scratch(es), LI - Repair and paint (complete)	<b>259,80</b>

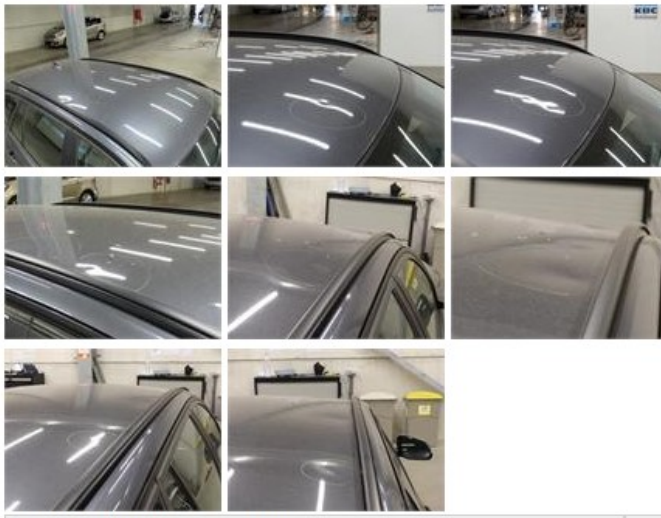
Roof, Dent(s), LI - Repair and paint (complete)	625,50
---	--------
