**LU Audi q5: BB8881**

**Limited Technical Inspection**

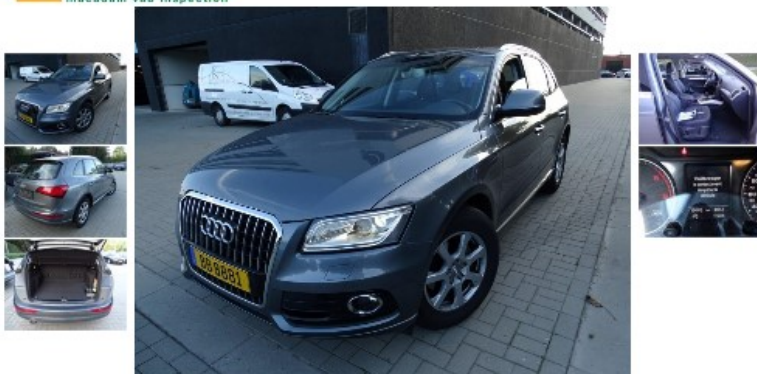
| <b>Bumper R, Dent(s) and scratch(es), LI - Repair and paint (complete)</b> | <b>254,16</b> |

Door R L, Dent(s), PDR - Paintless dent repair 63,00
