## VOLVO V40: 1JFR522

## Limited Technical Inspection

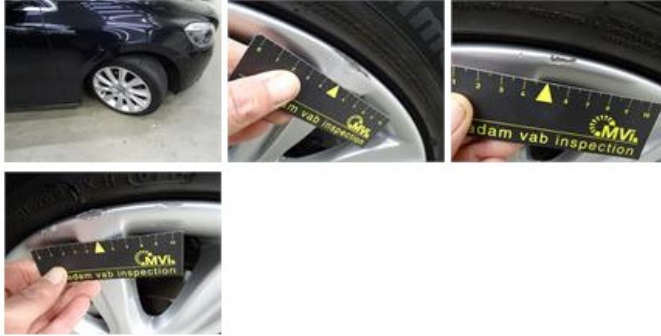
Wing R L, Scratch(es), Acceptable	0,00
<i>No pictures to display</i>	
Bonnet, Scratch(es), Acceptable	0,00
<i>No pictures to display</i>	
Wing R R, Scratch(es), Acceptable	0,00
<i>No pictures to display</i>	
Bumper F, Dent(s) and scratch(es), Acceptable	0,00
<i>No pictures to display</i>	
Alloy rim F R, Scratch(es), LI - Repair and paint (complete)	95,00
