VOLVO XC60: 1HZV993

Limited Technical Inspection

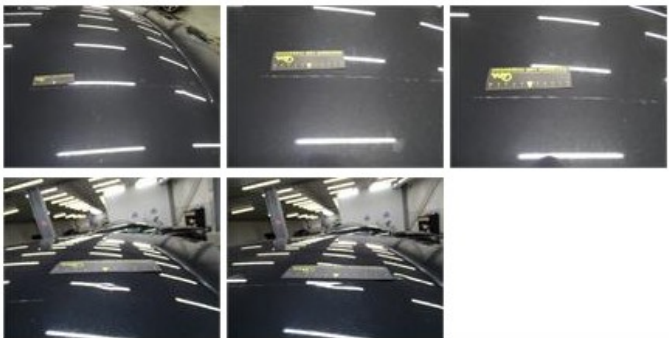
Door F L, Dent(s), Acceptable	0,00
<i>No pictures to display</i>	
Roof, Dent(s) and scratch(es), LI - Repair and paint (complete)	577,80
