BMW 3: 1GHF475			
Vinnumber:	WBA3L11040K176088	Versionname:	3 TOURING 320d Eff.Dyn.Ed. 163PK
First Registrationdate:	7/02/2014	Fiscalpower:	
Expertise Mileage:	89036	Power Kw:	120
Bodytype:	Break	Body color:	Red
Gearbox:	MAN 6 VIT	Paint type:	Metalic
Transmission:		Rims summer:	Aluminium
Fueltype:	Diesel	Oil level:	OK
Battery functioning:	Yes	Parking lot:	2213
Number of doors:	5		
Number of seats:	5		
Number head rests:	5		
Rims summer:	Aluminium		
Category:	Passenger Car		
Oil level:	OK		
Registration Certificate Car (BE):	Yes

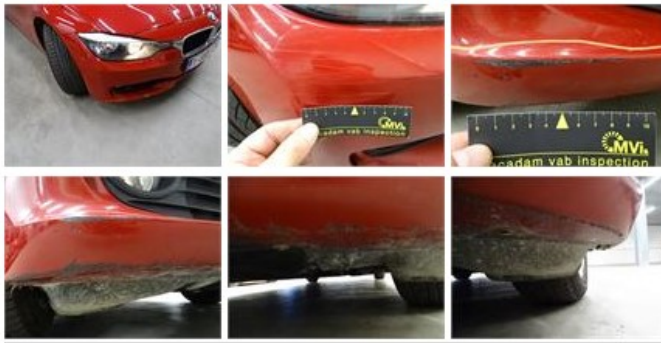
Wing R R, Scratch(es), Acceptable	0,00
<i>No pictures to display</i>	
Bonnet, Stone chip(s), Acceptable	0,00
<i>No pictures to display</i>	
Bumper F, Scratch(es), LI - Repair and paint (complete)	211,80
