VOLKSWAGEN SHARAN: BC5104

Vinnumber:	WVWZZZ7NZFV033039	Versionname:	2.0 CR TDI 103KW COMFORTLINE BMT
First Registrationdate:	1/03/2016	Fiscalpower:	
Expertise Mileage:	144742	Power Kw:	103
Bodytype:		Body color:	Black
Gearbox:	MAN 6 VIT	Paint type:	Metalic
Transmission:	Front	Rims summer:	Aluminium
Fueltype:	Diesel	Oil level:	OK
Maintenance:	IN 17000KM	Parking lot:	2121
Maintenance:	OK		
Battery functioning:	Yes		
Number of doors:	5		
Number of seats:	7		
Number head rests:	7		
Rims summer:	Aluminium		
Category:	Passenger Car		
Oil level:	OK		
Registration Certificate Car (BE):	No

Limited Technical Inspection

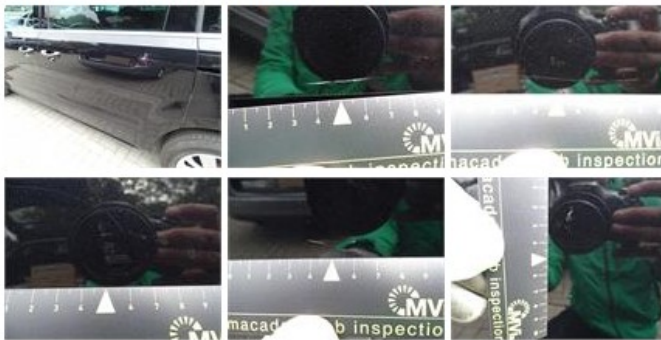
Door R L, Scratch(es), LI - Repair and paint (complete)	318,35
---------------------------------------------------------	--------
