BMW SERIE 3: 1HSV114

Limited Technical Inspection

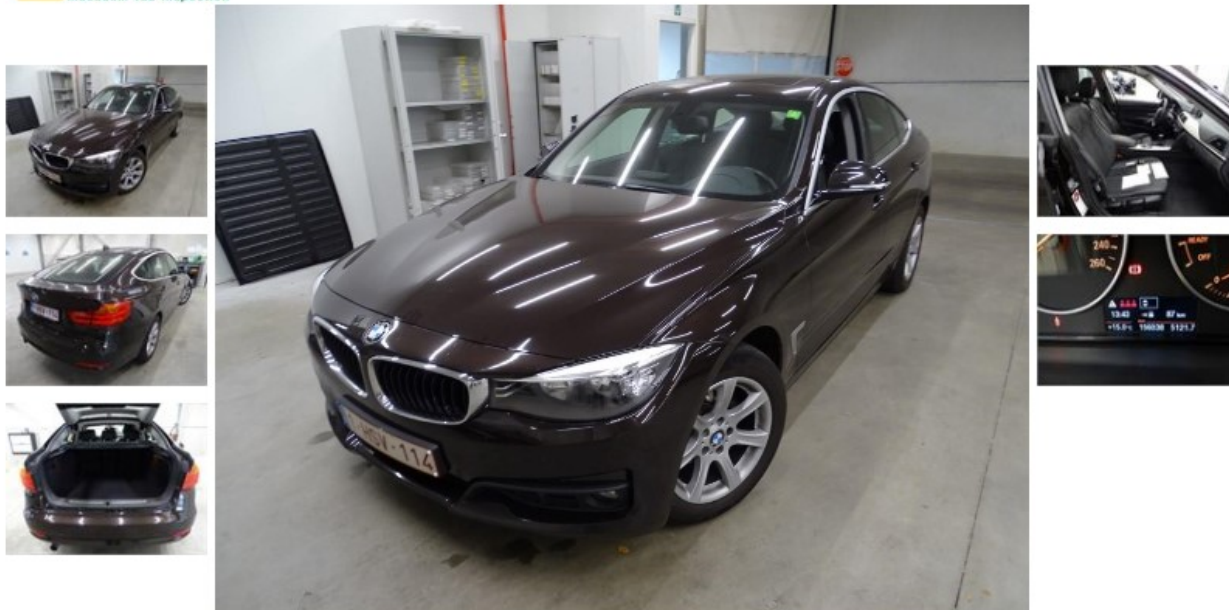
Wing R R, Scratch(es), 67 - Polish	0,00
------------------------------------	-------------

Tailgate, Chemical polution, LI - Repair and paint (complete)
