**LAND ROVER RANGE ROVER EVOQUE: FZ9299**

**Limited Technical Inspection**

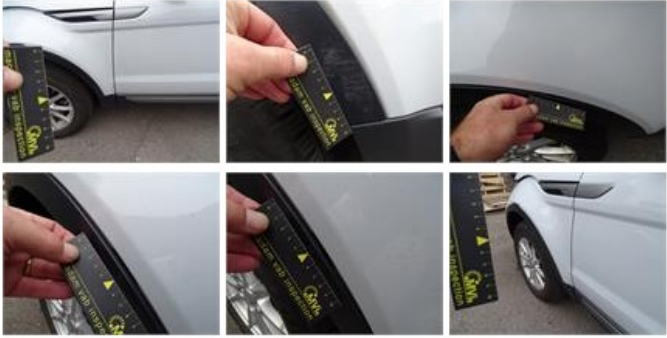
<i>No pictures to display</i>	
Bumper R, Scratch(es), Acceptable	0,00
<i>No pictures to display</i>	
Door F R, Dent(s), Acceptable	0,00
<i>No pictures to display</i>	
Armrest F Mid, Deformed / Strained, Acceptable	0,00
<i>No pictures to display</i>	
Spoiler F R, Chemical polution, Acceptable	0,00
<i>No pictures to display</i>	
Wheel arch cover F L, Scratch(es), E - Replace	74,00
