RENAULT Scenic: 1KCK270

Limited Technical Inspection

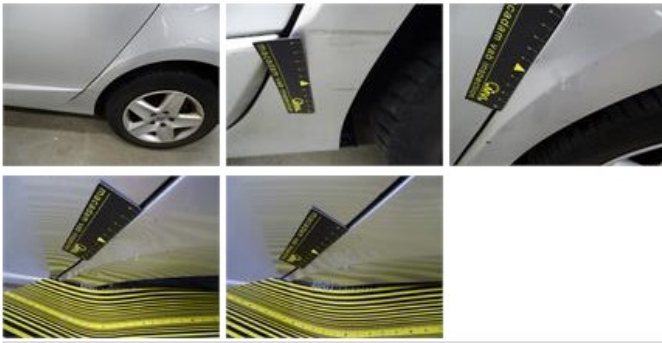
Wing R L, Dent(s) and scratch(es), LI - Repair and paint (complete)	308,20
---	---------------

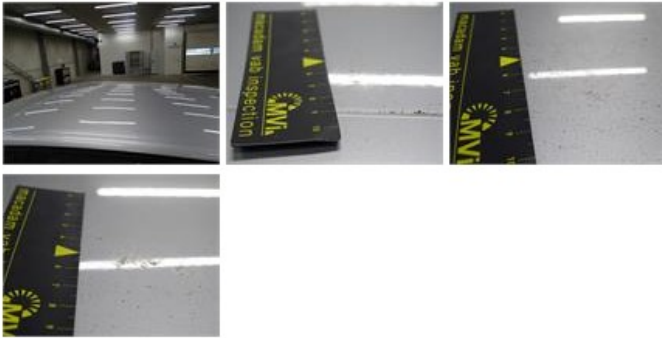
Tailgate, Bad repair, Acceptable	0,00
<i>No pictures to display</i>	
Door R L, Scratch(es), Acceptable	0,00
<i>No pictures to display</i>	
Bumper R, Scratch(es), Acceptable	0,00
<i>No pictures to display</i>	
Wing R R, Scratch(es), Acceptable	0,00
<i>No pictures to display</i>	
Door F R, Scratch(es), Acceptable	0,00
<i>No pictures to display</i>	
Door F L, Scratch(es), Acceptable	0,00
<i>No pictures to display</i>	
Roof, Chemical polution, LI - Repair and paint (complete)	481,50
