**AUDI A6: 1HYT706**

**Limited Technical Inspection**

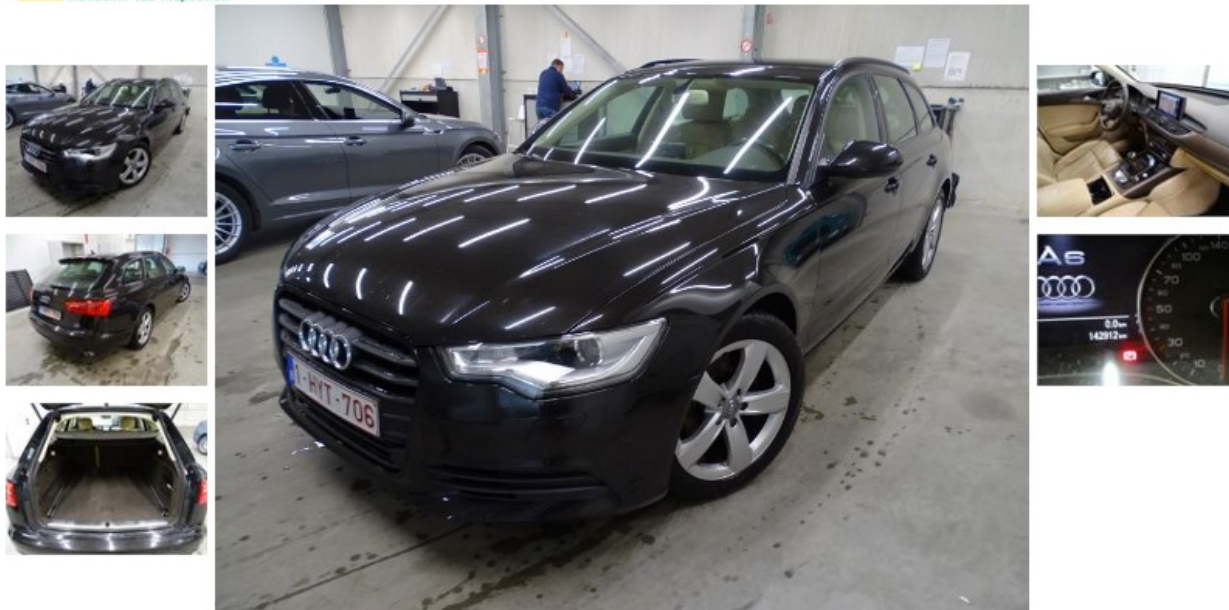
Vinnumber:	<b>WAUZZZ4G8EN201130</b>	Versionname:	<b>A6 AVANT Ultra 190PK</b>
First Registrationdate:	<b>31/10/2014</b>	Fiscalpower:	
Expertise Mileage:	<b>142912</b>	Power Kw:	<b>140</b>
Bodytype:	<b>Break</b>	Body color:	<b>Brown</b>
Gearbox:	<b>MAN 6 VIT</b>	Paint type:	<b>Metalic</b>
Transmission:	<b>Front</b>	Rims summer:	<b>Aluminium</b>
Fueltype:	<b>Diesel</b>	Oil level:	<b>OK</b>
Battery functioning:	<b>Yes</b>	Parking lot:	<b>2713</b>
Number of doors:	<b>5</b>		
Number of seats:	<b>5</b>		
Number head rests:	<b>5</b>		
Rims summer:	<b>Aluminium</b>		
Category:	<b>Passenger Car</b>		
Oil level:	<b>OK</b>		
Registration Certificate Car (BE):	<b>Yes</b>
