CITROEN DS4: 1FSE181

Limited Technical Inspection

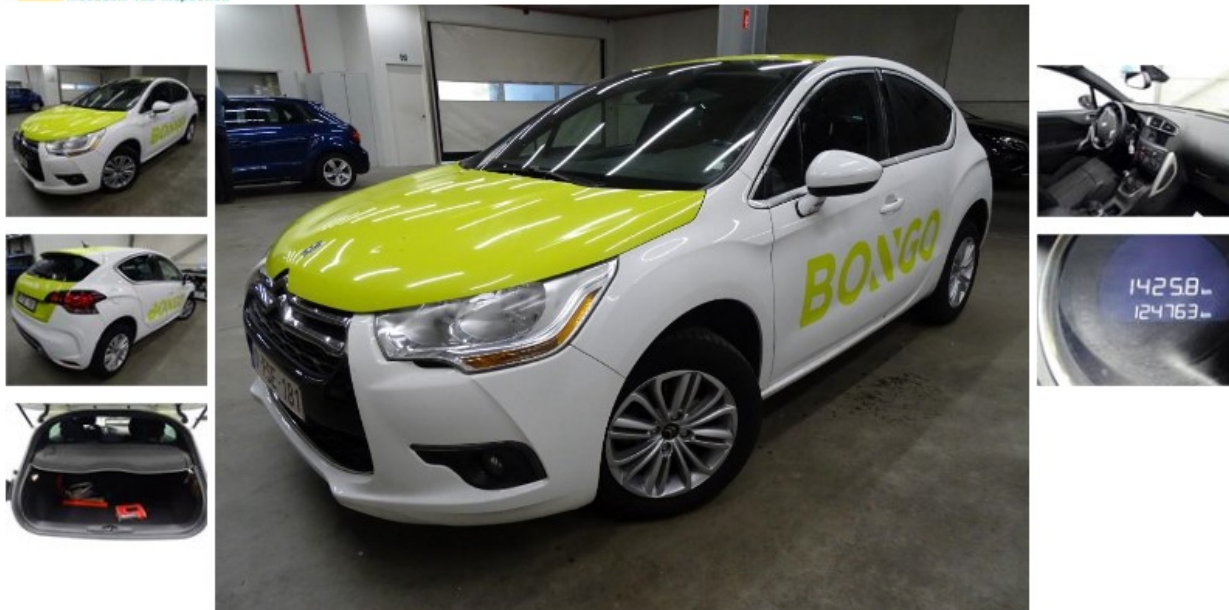
Vinnumber:	VF7NX9HD8DY592769	Versionname:	DS4 BER e-HDi Business GPS 115PK
First Registrationdate:	8/10/2013	Fiscalpower:	
Expertise Mileage:	124763	Power Kw:	84
Bodytype:	Hatchback	Body color:	White
Gearbox:	MAN 6 VIT	Paint type:	Metalic
Transmission:	Front	Rims summer:	Aluminium
Fueltype:	Diesel	Oil level:	OK
Battery functioning:	Yes	Parking lot:	2119
Number of doors:	5		
Number of seats:	5		
Number head rests:	5		
Rims summer:	Aluminium		
Category:	Passenger Car		
Oil level:	OK		
Registration Certificate Car (BE):	Yes
