VOLVO V40: 1HYP447

Limited Technical Inspection

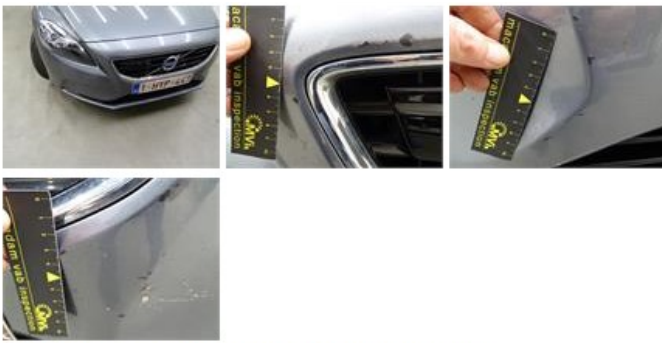
Repair kit	Yes	Compressor	Yes
Total cost ex VAT			741,80
Bumper F, Scratch(es), LI - Repair and paint (complete)			211,80
