NISSAN Qashqai: 1GJU129

Limited Technical Inspection

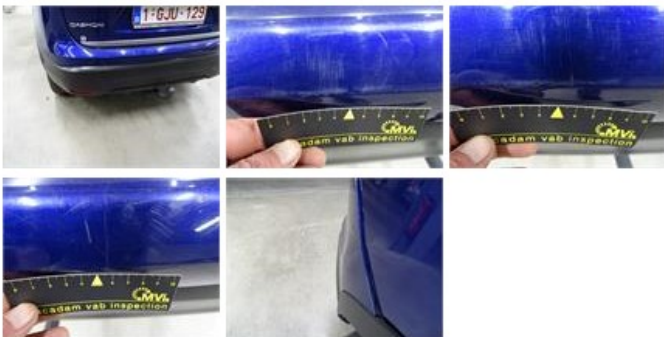
Door R R, Scratch(es), Acceptable	0,00
<i>No pictures to display</i>	
Bumper R, Scratch(es), LI - Repair and paint (complete)	211,80
