BMW 3: 1JFD638

Limited Technical Inspection

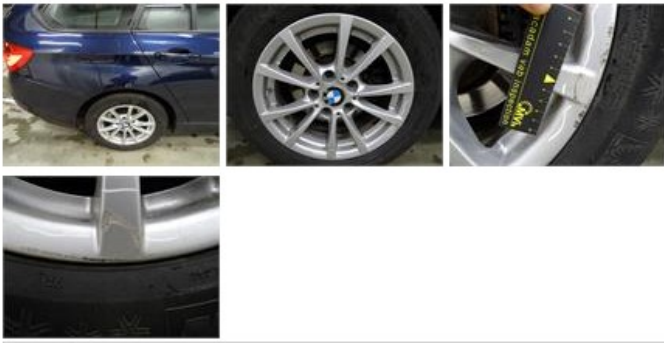
Repair kit	Yes	Compressor	Yes
Total cost ex VAT			190,00
Door R R, Scratch(es), Acceptable			0,00
<i>No pictures to display</i>			
Door R L, Scratch(es), Acceptable			0,00
<i>No pictures to display</i>			
Alloy rim R R, Scratch(es), LI - Repair and paint (complete)			95,00

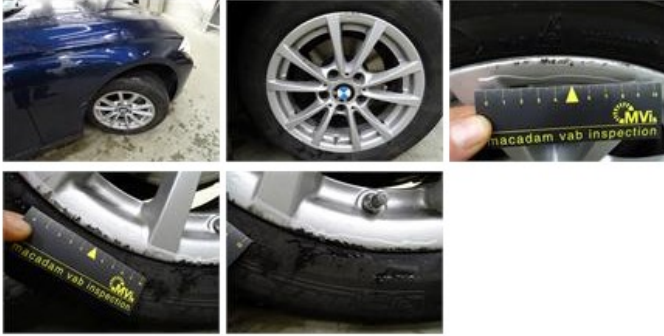
Alloy rim F R, Scratch(es), LI - Repair and paint (complete)

95,00
