SEAT Alhambra: 1GDI388

Limited Technical Inspection

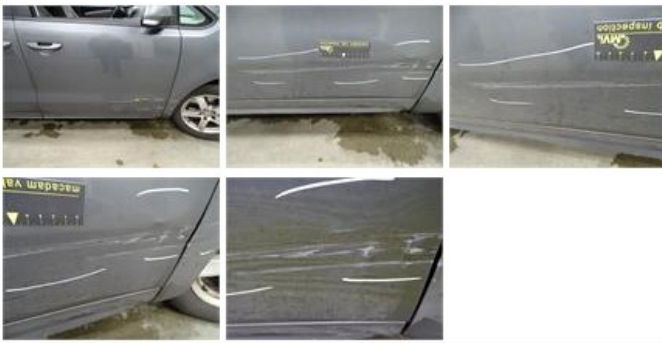
Total cost ex VAT	1548,96
Bumper R, Scratch(es), Acceptable	0,00
<i>No pictures to display</i>	
Wing R R, Dent(s), Acceptable	0,00
<i>No pictures to display</i>	
Door F R, Dent(s) and scratch(es), LI - Repair and paint (complete)	382,02
