BMW 5 BERLINE: 1JXG710			
Vinnumber:	WBA5E310X0D672922	Versionname:	2.0 518D (100KW)
First Registrationdate:	12/03/2015	Fiscalpower:	
Expertise Mileage:	130010	Power Kw:	100
Bodytype:		Body color:	Black
Gearbox:	Automatic	Paint type:	Metalic
Transmission:		Rims summer:	Aluminium
Fueltype:	Diesel	Oil level:	OK
Battery functioning:	Yes	Parking lot:	1208
Number of doors:	4		
Number of seats:	5		
Number head rests:	5		
Rims summer:	Aluminium		
Category:	Passenger Car		
Oil level:	OK		
Registration Certificate Car (BE):	Yes

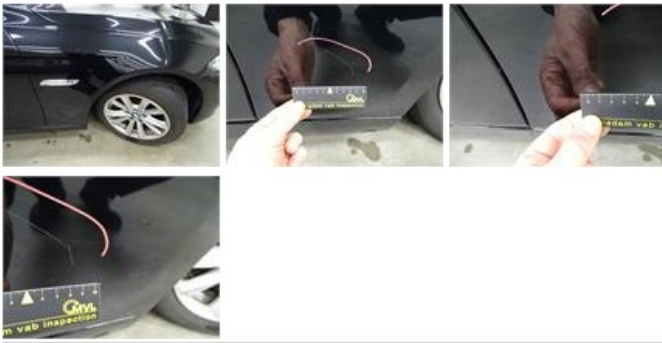
Assistance equipment	
Total cost ex VAT	646,23
Bonnet, Chemical polution, 67 - Polish	0,00
<i>No pictures to display</i>	
Wing F R, Scratch(es), LI - Repair and paint (complete)	264,21

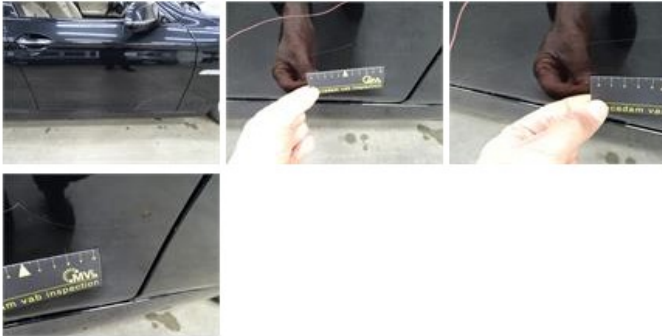
Wing R L, Scratch(es), Acceptable	0,00
<i>No pictures to display</i>	
Wing R R, Scratch(es), Acceptable	0,00
<i>No pictures to display</i>	
Door F R, Scratch(es), LI - Repair and paint (complete)	382,02
