BMW 1 HATCH: 1LHC538

Limited Technical Inspection

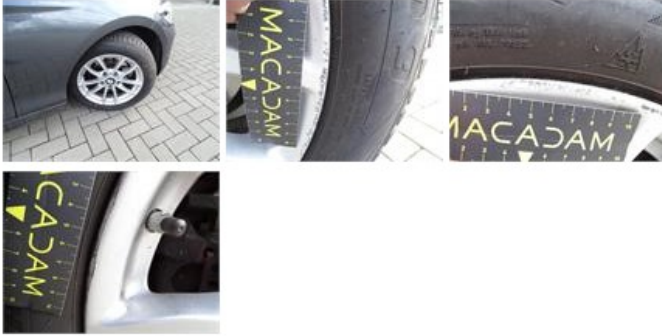
Bumper R, Repaired, Acceptable	0,00
<i>No pictures to display</i>	
Tailgate, Scratch(es), Acceptable	0,00
<i>No pictures to display</i>	
Bumper F, Repaired, Acceptable	0,00
<i>No pictures to display</i>	
Alloy rim F L, Scratch(es), Acceptable	0,00
<i>No pictures to display</i>	
Alloy rim F R, Scratch(es), LI - Repair and paint (complete)	95,00
