VOLKSWAGEN Sharan: 1JLV334

Limited Technical Inspection

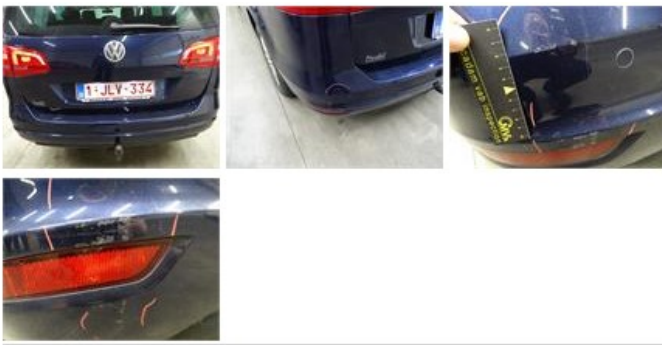
Total cost ex VAT	1377,41
Wing F L, Scratch(es), Acceptable	0,00
<i>No pictures to display</i>	
Bumper R, Scratch(es), LI - Repair and paint (complete)	254,16

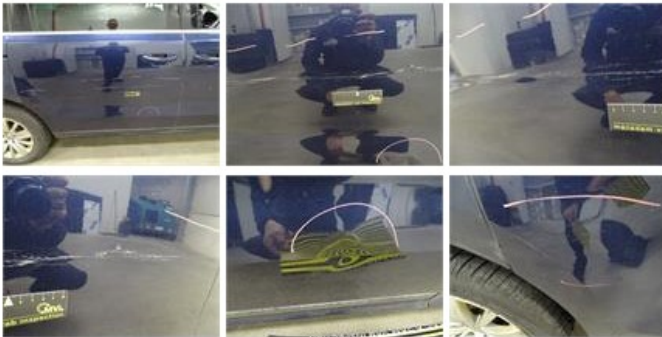
Door R R, Dent(s) and scratch(es), LI - Repair and paint (complete) 382,02
