BMW 3: 1HEH059			
Vinnumber:	WBA3D11080J627459	Versionname:	3 BER 318d 136PK
First Registrationdate:	1/07/2014	Fiscalpower:	
Expertise Mileage:	160751	Power Kw:	100
Bodytype:		Body color:	Blue
Gearbox:	MAN 6 VIT	Paint type:	Metalic
Transmission:	Back	Rims summer:	Aluminium
Fueltype:	Diesel	Oil level:	OK
Battery functioning:	Yes	Parking lot:	2602
Number of doors:	4		
Number of seats:	5		
Number head rests:	5		
Rims summer:	Aluminium		
Category:	Passenger Car		
Oil level:	OK		
Registration Certificate Car (BE):	Yes

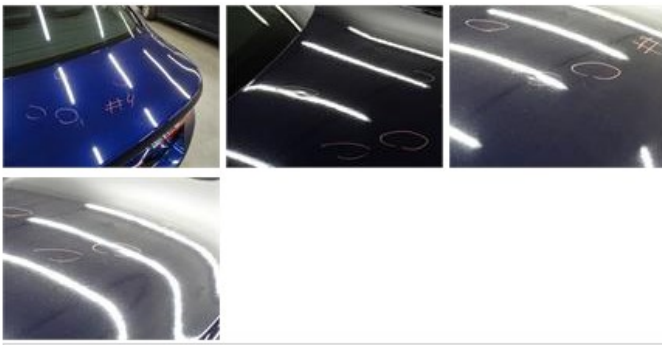
Assistance equipment			
Repair kit	Yes	Compressor	Yes
Total cost ex VAT			921,20
Alloy rim R R, Scratch(es), Acceptable			0,00
<i>No pictures to display</i>			
Tailgate, Hail damage, PDR - Hail			100,00

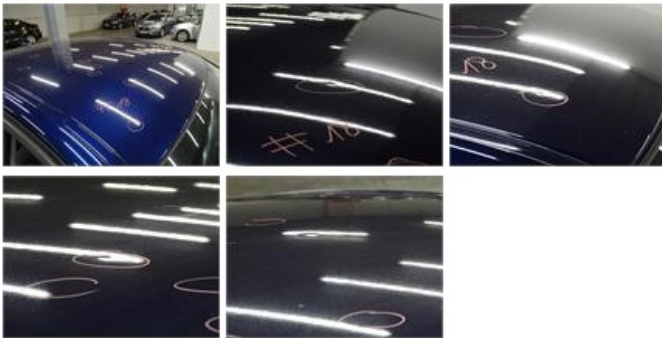
Roof, Hail damage, PDR - Hail 450,00
