**PEUGEOT 308 SW: 1LNT564**

**Limited Technical Inspection**

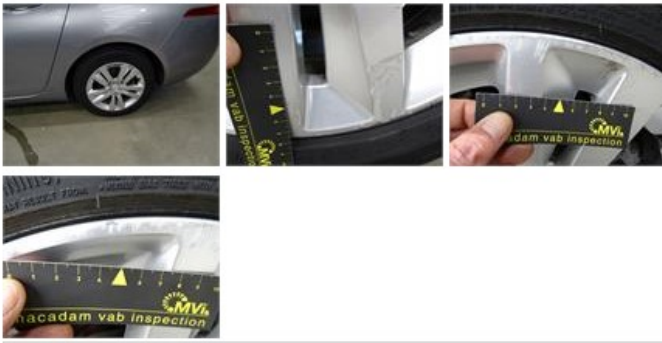
Total cost ex VAT	<b>190,00</b>
Door F L, Dent(s) and scratch(es), Acceptable	<b>0,00</b>
<i>No pictures to display</i>	
Alloy rim R L, Scratch(es), LI - Repair and paint (complete)	<b>95,00</b>
