BMW 2 ACTIVE TOURER: 1KAN459

Limited Technical Inspection

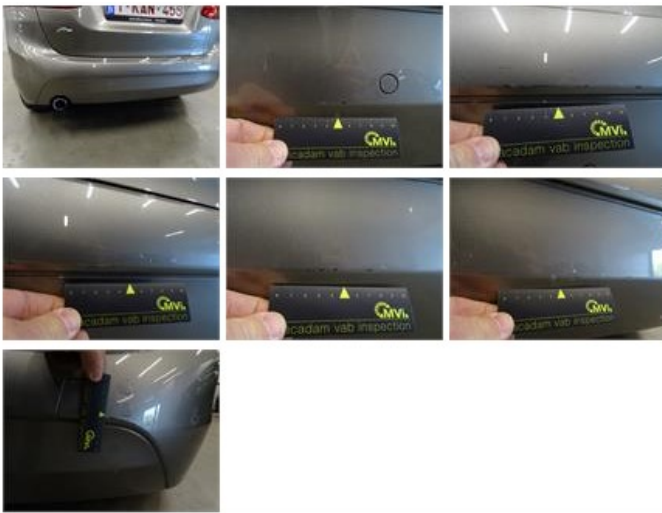
Repair kit	Yes	Compressor	Yes
Total cost ex VAT			618,82
Alloy rim R R, Scratch(es), Acceptable			0,00
<i>No pictures to display</i>			
Wing R R, Scratch(es), Acceptable			0,00
<i>No pictures to display</i>			
Bumper R, Scratch(es), LI - Repair and paint (complete)			211,80

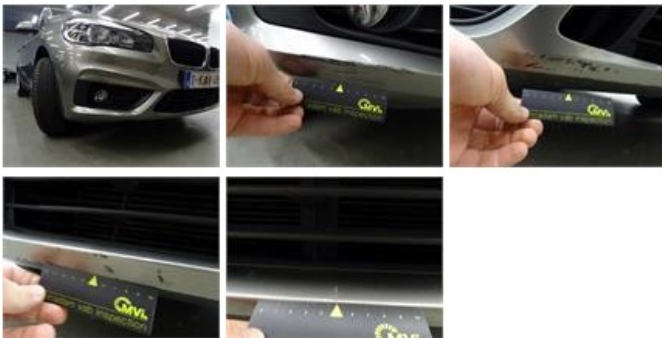
Bumper F, Scratch(es), LI - Repair and paint (complete) 211,80
