OPEL Movano 3500 MWB Med.High Roof: 1GEZ737

Limited Technical Inspection

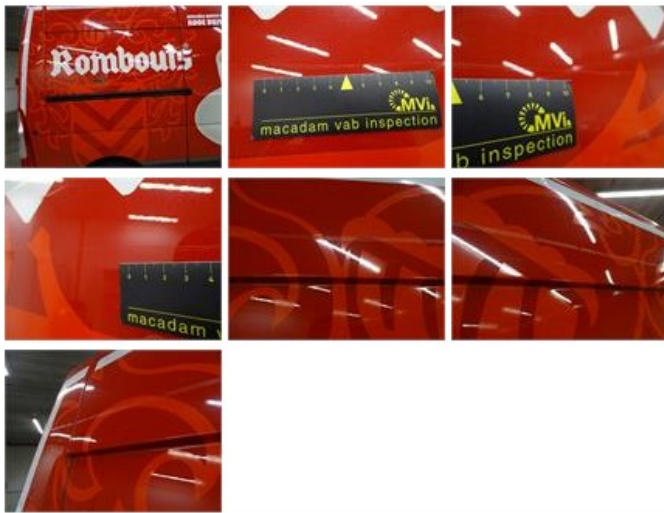
Total cost ex VAT	1421,12
Wing F R, Dent(s), Acceptable	0,00
<i>No pictures to display</i>	
Door R R, Dent(s) and scratch(es), Acceptable	0,00
<i>No pictures to display</i>	
Wing R R, Scratch(es), LI - Repair and paint (complete)	231,15

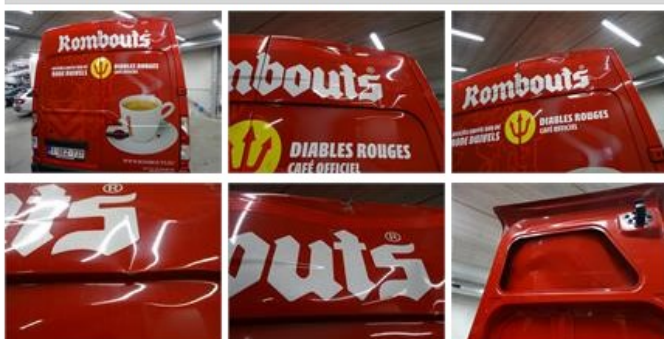
Trunk door R R, Dent(s) and scratch(es), Le - Replace and paint 0,00
