BMW 3: 1WDA528

Limited Technical Inspection

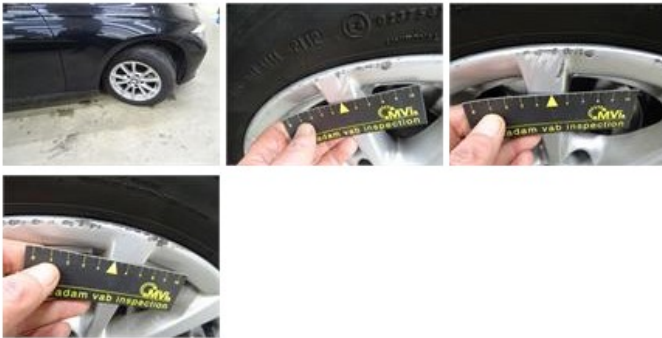
Alloy rim F L, Scratch(es), Acceptable	0,00
<i>No pictures to display</i>	
Ignition key, Missing, E - Replace	150,00
<i>No pictures to display</i>	
Certificate Of Conformity, Missing, E - Replace	150,00
<i>No pictures to display</i>	
Bumper R, Scratch(es), Acceptable	0,00
<i>No pictures to display</i>	
Door R L, Dent(s) and scratch(es), Acceptable	0,00
<i>No pictures to display</i>	
Alloy rim R R, Scratch(es), Acceptable	0,00
<i>No pictures to display</i>	
Alloy rim F R, Scratch(es), LI - Repair and paint (complete)	95,00
