BMW 1 HATCH: FA5882

Vinnumber:	WBA1C71040P841021	Versionname:	2.0 116D (85KW)
First Registrationdate:	23/01/2015	Fiscalpower:	
Expertise Mileage:	121268	Power Kw:	85
Bodytype:	Hatchback	Body color:	Black
Gearbox:	MAN 6 VIT	Paint type:	Metalic
Transmission:	Back	Rims summer:	Aluminium
Fueltype:	Diesel	Oil level:	OK
Battery functioning:	Yes	Parking lot:	2227
Number of doors:	5		
Number of seats:	5		
Number head rests:	5		
Rims summer:	Aluminium		
Category:	Passenger Car		
Oil level:	OK		
Registration Certificate Car (BE):	Yes

Limited Technical Inspection

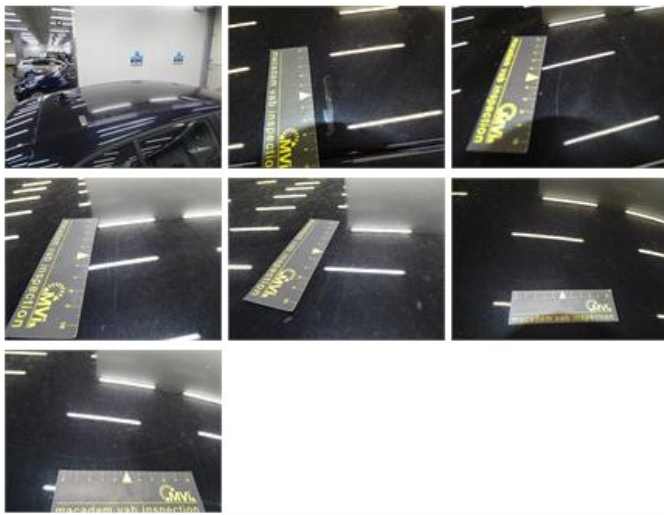
Total cost ex VAT	913,48
Alloy rim F R, Scratch(es), Acceptable	0,00
<i>No pictures to display</i>	
Roof, Scratch(es), LI - Repair and paint (complete)	481,50

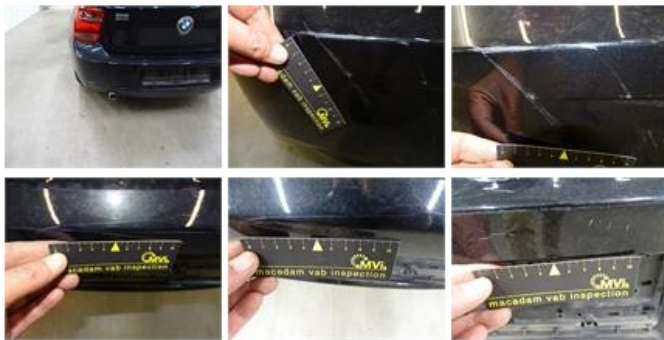
Bumper R, Scratch(es), LI - Repair and paint (complete) 211,80
