BMW 3: 1GJE571

Limited Technical Inspection

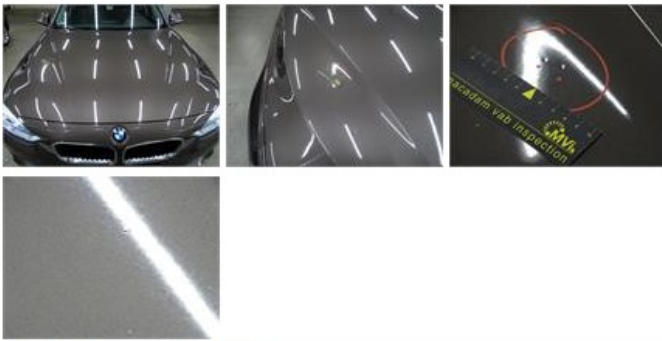
Repair kit	Yes	Compressor	Yes
Total cost ex VAT			0,00
Door F R, Scratch(es), Acceptable			0,00
<i>No pictures to display</i>			
Rear window, Scratch(es), Acceptable			0,00
<i>No pictures to display</i>			
Wing R L, Dent(s), Acceptable			0,00
<i>No pictures to display</i>			
Bonnet, Bad repair, Acceptable			0,00
