BMW 3: 1EYA598

Limited Technical Inspection

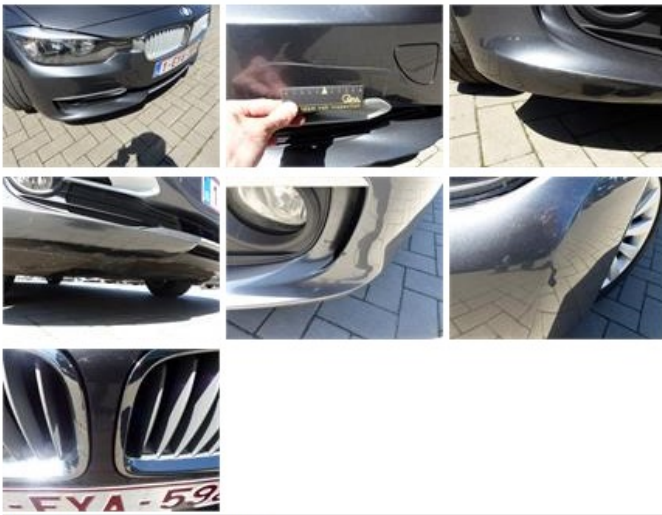
Runflat	Yes
Total cost ex VAT		211,80
Seat cover F R, Stain, Acceptable		0,00
<i>No pictures to display</i>		
Wing R R, Scratch(es), Acceptable		0,00
<i>No pictures to display</i>		
Alloy rim R L, Scratch(es), Acceptable		0,00
<i>No pictures to display</i>		
Bumper F, Scratch(es), LI - Repair and paint (complete)		211,80
