MERCEDES CLA: 1JUL982

Limited Technical Inspection

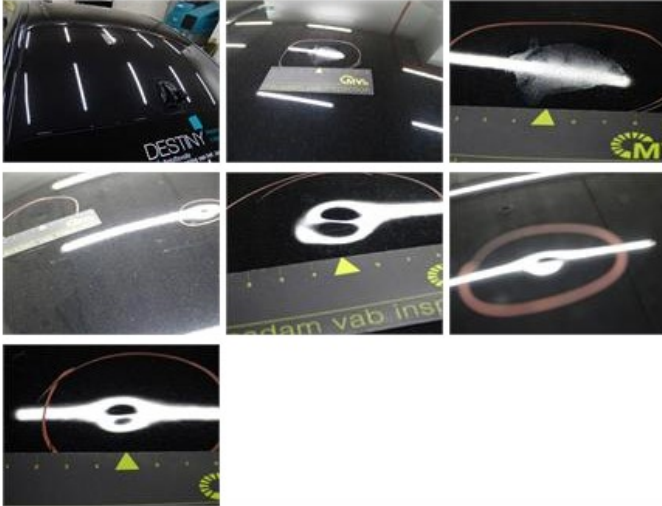
Alloy rim R L polished, Scratch(es), Acceptable	0,00
<i>No pictures to display</i>	
Door R R, Scratch(es), Acceptable	0,00
<i>No pictures to display</i>	
Bumper F, Scratch(es), Acceptable	0,00
<i>No pictures to display</i>	
Bumper R, Scratch(es), Acceptable	0,00
<i>No pictures to display</i>	
Door F R, Scratch(es), Acceptable	0,00
<i>No pictures to display</i>	
Roof, Chemical pollution, LI - Repair and paint (complete)	481,50
