BMW 3 TOURING: 1JUS153

Limited Technical Inspection

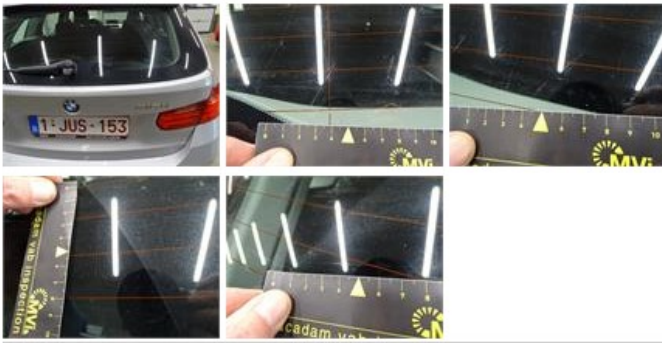
Total cost ex VAT	774,08
Alloy rim F L, Scratch(es), Acceptable	0,00
<i>No pictures to display</i>	
Roof pillar R, Dent(s), Acceptable	0,00
<i>No pictures to display</i>	
Rear window, Scratch(es), E - Replace	370,00
