## VOLKSWAGEN Golf: 1GWT397

## Limited Technical Inspection

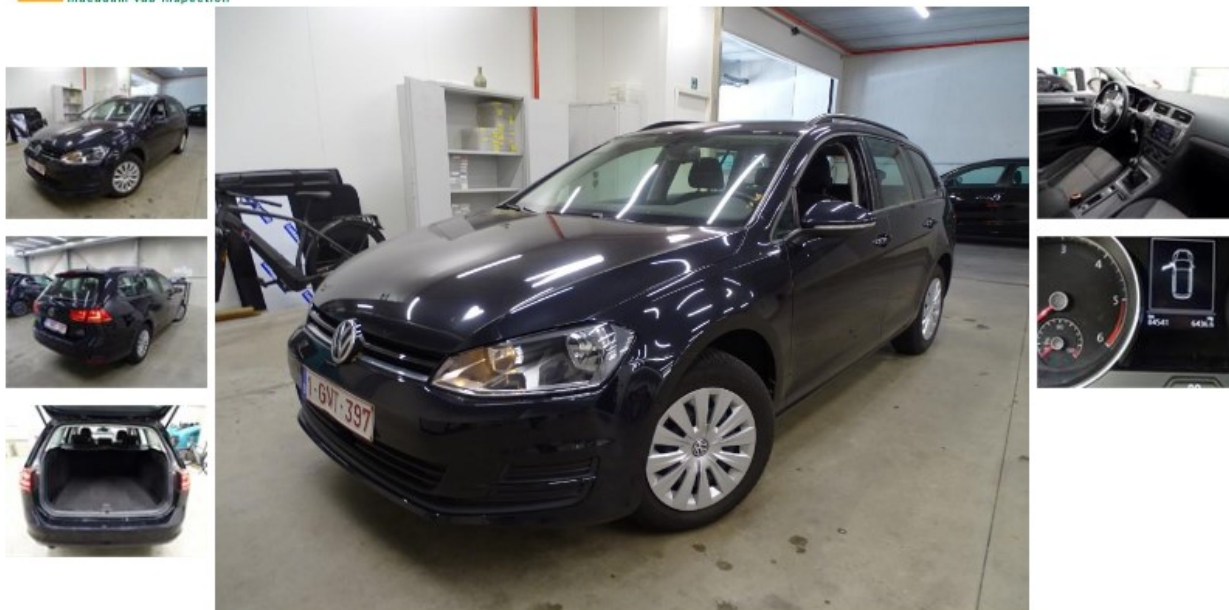
Total cost ex VAT	766,56
Wing R L, Bad repair, LI - Repair and paint (complete)	0,00

Bumper R, Broken, Le - Replace and paint

Bumper F, Scratch(es), It - Spot repair
