**CITROEN C4 Picasso: 1GVB806**

**Limited Technical Inspection**

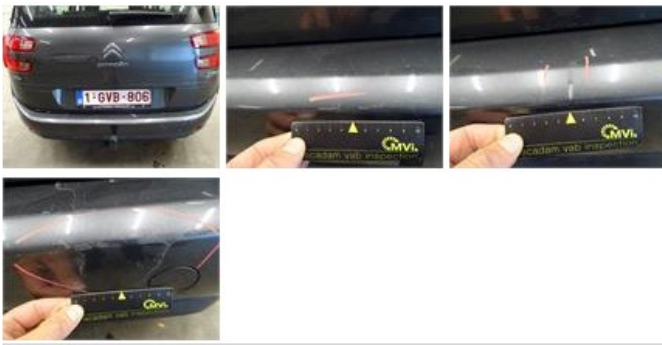
Total cost ex VAT	629,24
Alloy rim F R, Scratch(es), Acceptable	0,00
<i>No pictures to display</i>	
Bumper R, Scratch(es), LI - Repair and paint (complete)	211,80

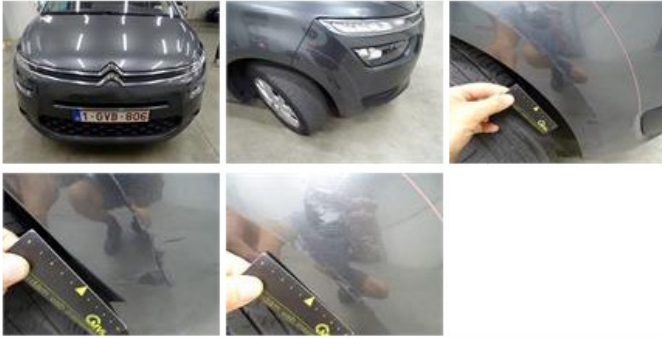
Bumper F, Scratch(es), LI - Repair and paint (complete) 211,80
